**Flood Control Project Maintenance
Levee Inspections**

Maintenance Issue Types Only, Levee Inspection Report By Mile - Spring 2018

Lake County Watershed Protection District

Waterway	Bank	Unit Miles	Inspection Start/End	Inspector
Unit No. 01 Middle Creek	Left	3.35	04/12/2018 04/12/2018	Bob Duffey

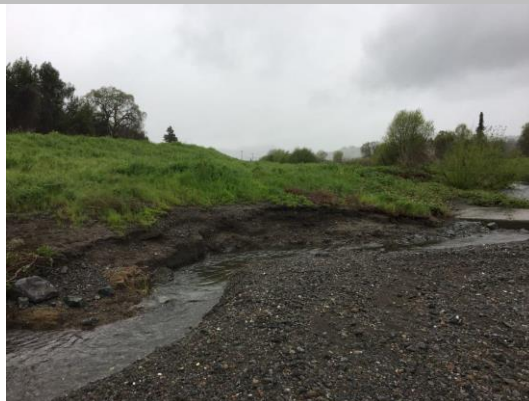
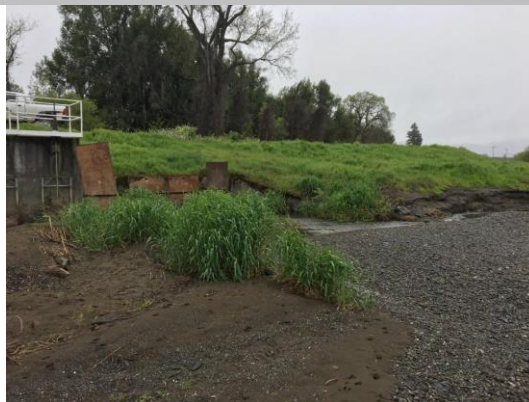
LM Start	0.32	Rating **	A/W	Issue No.	13 (cont)	
LM End	0.32	Issue Type +	Ma	Location *		
Category	Supplemental			GPS Latitude/Longitude		
				Start	End	
Item	2017 Storm Damage			39.177150 °	39.177150 °	
				-122.899111 °	-122.899111 °	
DWR ID	DWR_NA0009_05_f_2017_13					
Comment Code						
Inspector Comment						
Levee Evaluation Comments						
Description:						
Site ID No:19						
Site Designation:LCWPD-01						
Repair Type: Erosion						
Rating:Area of Concern						
Field Date:6/5/2017						
Notes: Erosion exists between a small weir and diversion pipes.

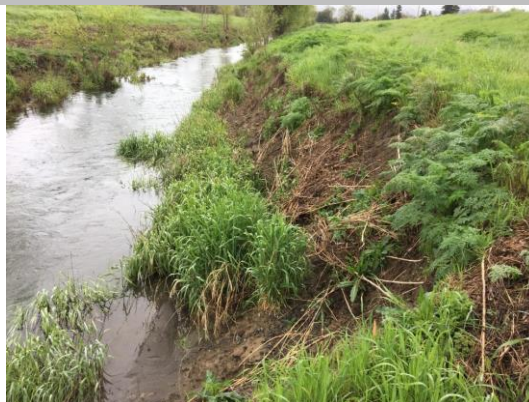
Photo 1 of 3 : LEVAL_SP_2018_20_340.jpg

LM Start	0.82	Rating **	A/W	Issue No.	20
LM End	0.86	Issue Type +	Ma	Location *	
Category	Supplemental			GPS Latitude/Longitude	
				Start	End
Item	2017 Storm Damage			39.175740 °	39.175750 °
				-122.907980 °	-122.908710 °
DWR ID	DWR_NA0009_05_f _ 2017_20				
Comment Code					
Inspector Comment					
Levee Evaluation Comments					
Description:					
Site ID No:20					
Site Designation:LCWPD-02					
Repair Type: Erosion					
Rating:Area of Concern					
Field Date:6/5/2017					
Notes: 5 - 7 ft deep erosion scarps, bank is normally near vertical but at a much smaller drop off, 1 - 3 ft.

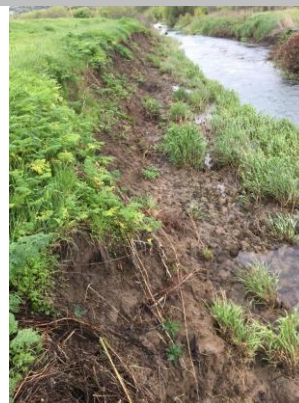
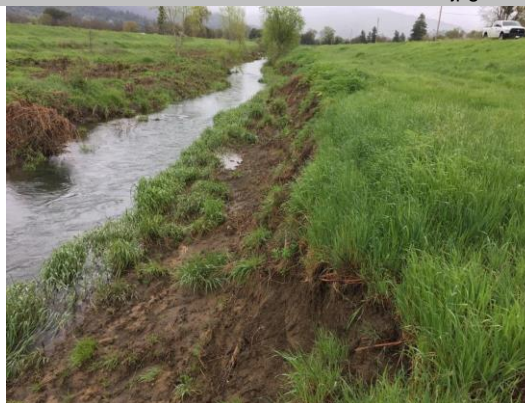
LM Start	0.82	Rating **	A/W	Issue No.	20 (cont)	
LM End	0.86	Issue Type +	Ma	Location *		
Category	Supplemental			GPS Latitude/Longitude		
				Start		End
Item	2017 Storm Damage			39.175740 °		39.175750 °
				-122.907980 °		-122.908710 °
DWR ID	DWR_NA0009_05_f_2017_20					
Comment Code						
Inspector Comment						
Levee Evaluation Comments						
Description:						
Site ID No:20						
Site Designation:LCWPD-02						
Repair Type: Erosion						
Rating:Area of Concern						
Field Date:6/5/2017						
Notes: 5 - 7 ft deep erosion scarps, bank is normally near vertical but at a much smaller drop off. 1 - 3 ft.
